Technical Report HL-96-22
December 1996

Demonstration Erosion Control Project Monitoring Program

Fiscal Year 1994 Report

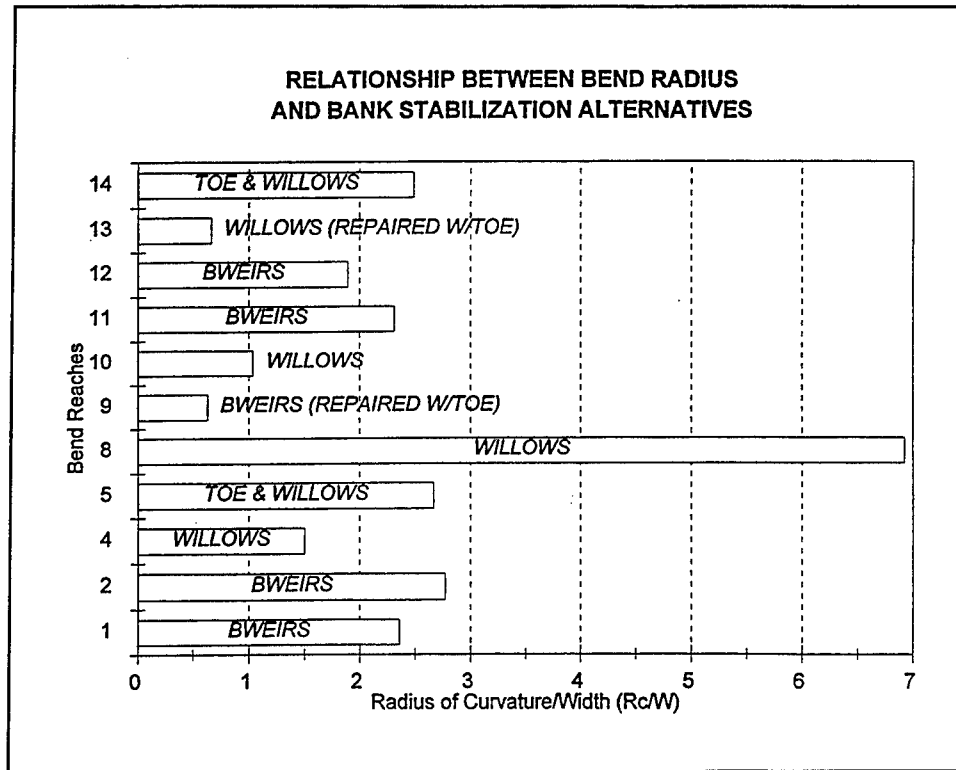
Figure 66. Relationship between R_c/W and bank stabilization alternatives

Figure 66 is a bar chart indicating the value of the radius of curvature to channel width ratio for each of the eleven bends within the fourteen stabilized reaches on Harland Creek. The labels on the bars indicate the type of stabilization that was emplaced. On bars 9 and 13, it is noted that the initial stabilization was repaired using a 2-ton-per-linear-foot longitudinal stone toe. The measured value of the R_c/W ratio was less than 0.65 for both of the bends requiring repair.

Reach 9 was initially stabilized using bendway weirs. Due to flanking of the weir and continued bank erosion at the downstream extent of the weir field, repair was made using the stone toe. Apparently, alignment and spacing of the bendway weirs, as constructed, were not adequate to control the erosion. It has been observed that traditional dikes require very close spacing on tight bends, and the necessity of repair in Reach 9 is an example of this malady for bendway weirs. No evidence was noted that the stone was too small for the imposed shear stress. In Reach 13 the four rows of willows failed due to excessive scour of the toe material. Willows were exposed to the flow with no soil covering the potential roots.

With the exception of Reach 9, bendway weirs have functioned adequately with R_c/W values of from 1.89 to 2.77. No repair of willow post stabilization has been required with R_c/W values from 1.03 to 1.50, except on Reach 13.

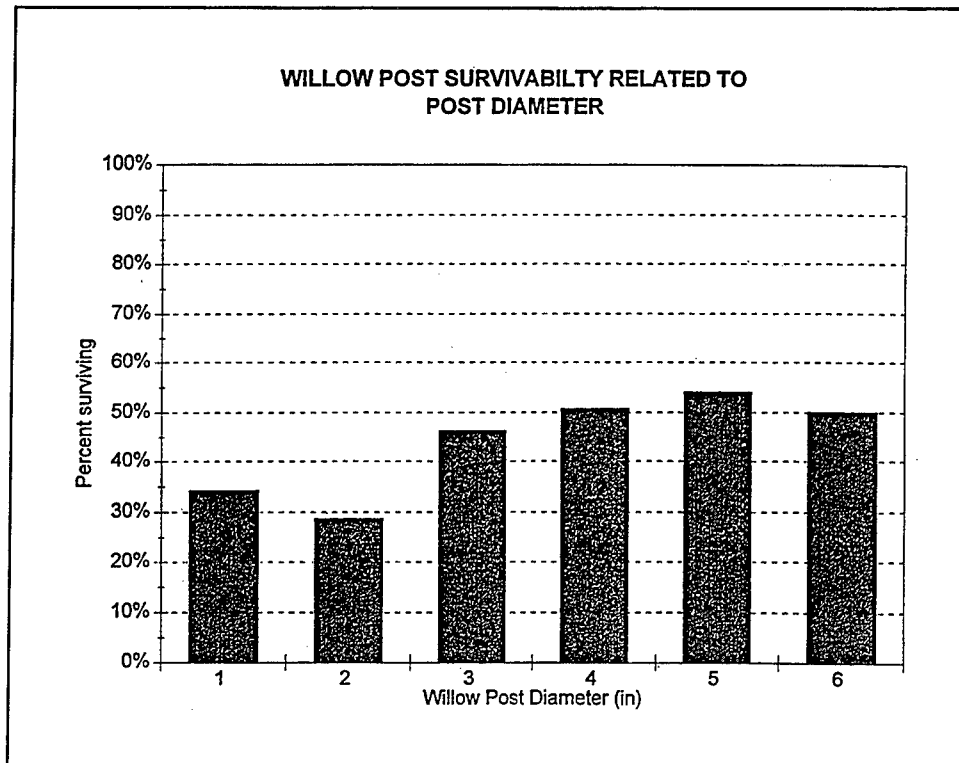
Figure 67. Willow post survivability related to post diameter

In 1994, the diameter of 293 dead and living willow posts was measured. The diameter of these posts ranged from 2 to 6.5 in. Each post was placed into a class based on diameter. The percent alive was then plotted versus the lower boundary of each class, as shown in Figure 67. The data indicate that the survivability increases as the diameter increases from 1 to 7 in.

Survival of the willow post is obviously necessary for long-term viability of the installation. The high mortality of willow posts can be attributed to insect infestation, lack of aerobic rooting conditions caused by impermeable soils, damage from high velocity, sediment-laden flood flows abrading the new growth, improper backfilling during construction, lack of sufficient moisture, and constant anaerobic rooting conditions due to standing water. The Harland Creek data suggest that the high mortality of the lower row of posts was the result of streamflow damage and the anaerobic conditions in standing water or poor soils. The high mortality of the upper rows, more than 6 ft above low water, may represent a site-specific threshold of sufficient moisture for sustaining growth.

Along with the recommended installation guidelines (Raphelt et al. 1995), the survivability of the willow posts at the Harland Creek site could have been improved by preventing erosion of the toe of the bank during the establishment period. Natural stone riprap placed at 1 ton per linear foot in a peaked longitudinal stone toe, continuous toe reinforcement using anchored cedar or willow trees, or use of manufactured products such as heavy fiber rolls placed along the toe, could be of benefit to system survivability. Interplanting of the willow posts with other species and the use of fascines buried along the rows would be of benefit in enhancing aggradation within the post system and could provide rooting medium in areas of poor soil conditions.

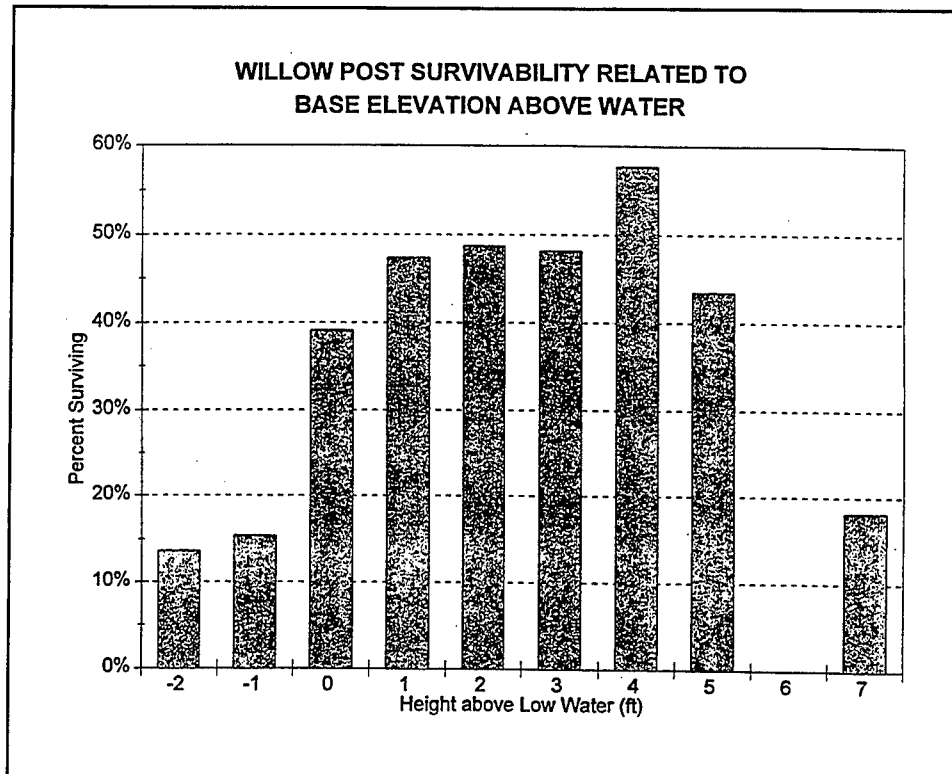
Figure 68. Willow post survivability as function of base elevation above low water

Similar to the diameter, the elevation at the base of the post above low water was measured for each of the 293 posts in the study reach. These elevations ranged from 2 ft below the water surface to 7.5 ft above the water surface level. The data were divided into classes of 1-ft increments, as shown in Figure 68. The data indicate that survivability reaches a minimum at the lower and upper ranges of the data. At several locations it was evident that scour of

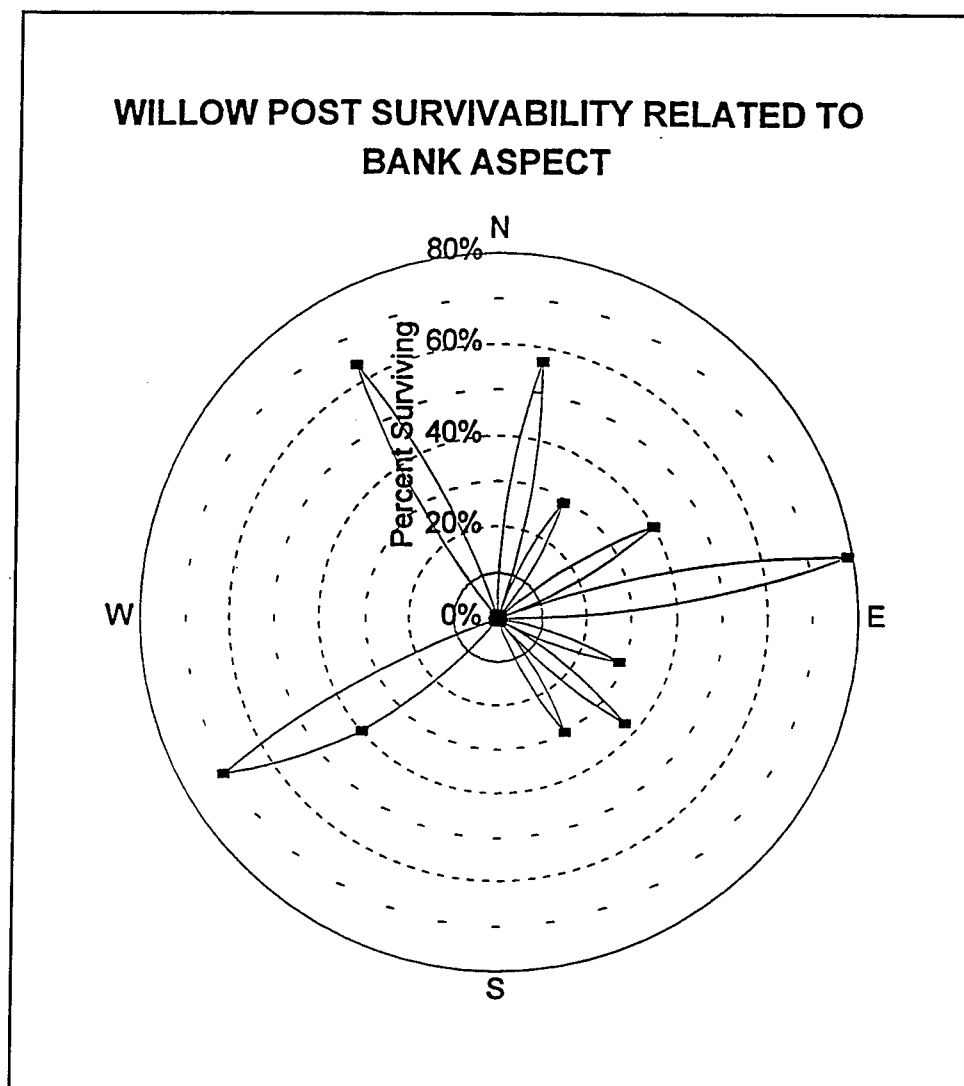
Figure 69. Willow post survivability as function of bank aspect

The aspect of the streambank, or the direction the bank faces, was measured using a Brunton compass. The aspect of the streambank data indicate that banks facing east or west have a greatest survival rate, and that banks facing north are better than banks facing south. Figure 69 portrays the aspect data.
